Memorandum

*Subject: Summary of Oversight of Equipment Servicing
August 13–14, 2019
Lower Passaic River Restoration Project*

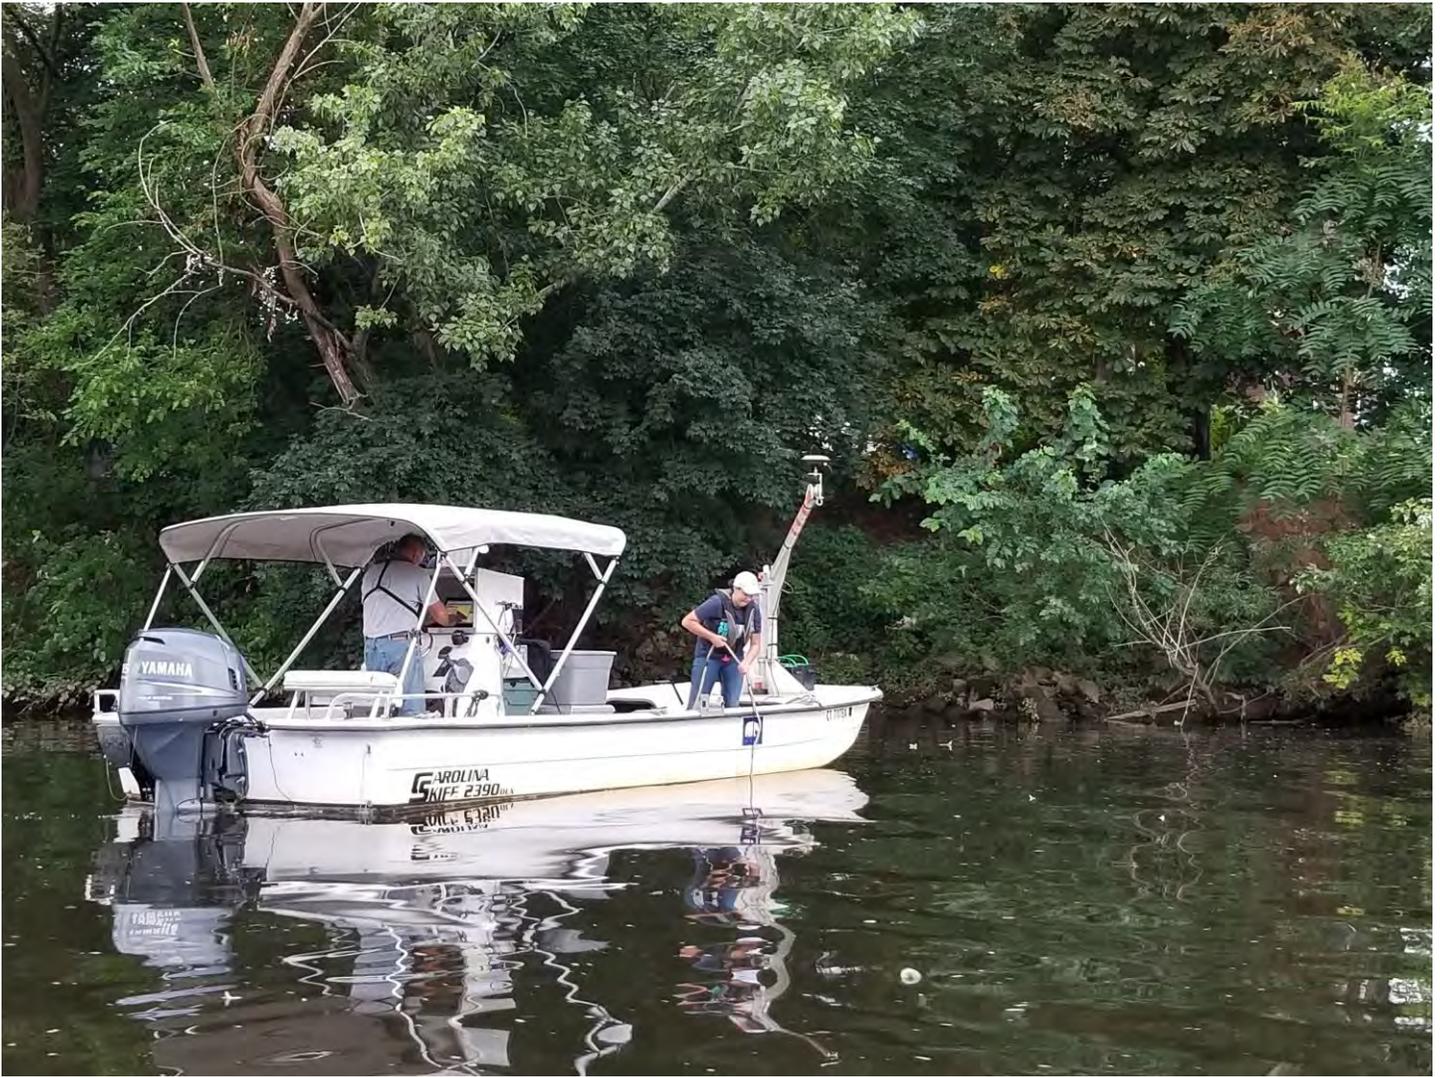
Photograph 1: OSI performing vertical profile at RM 15.8

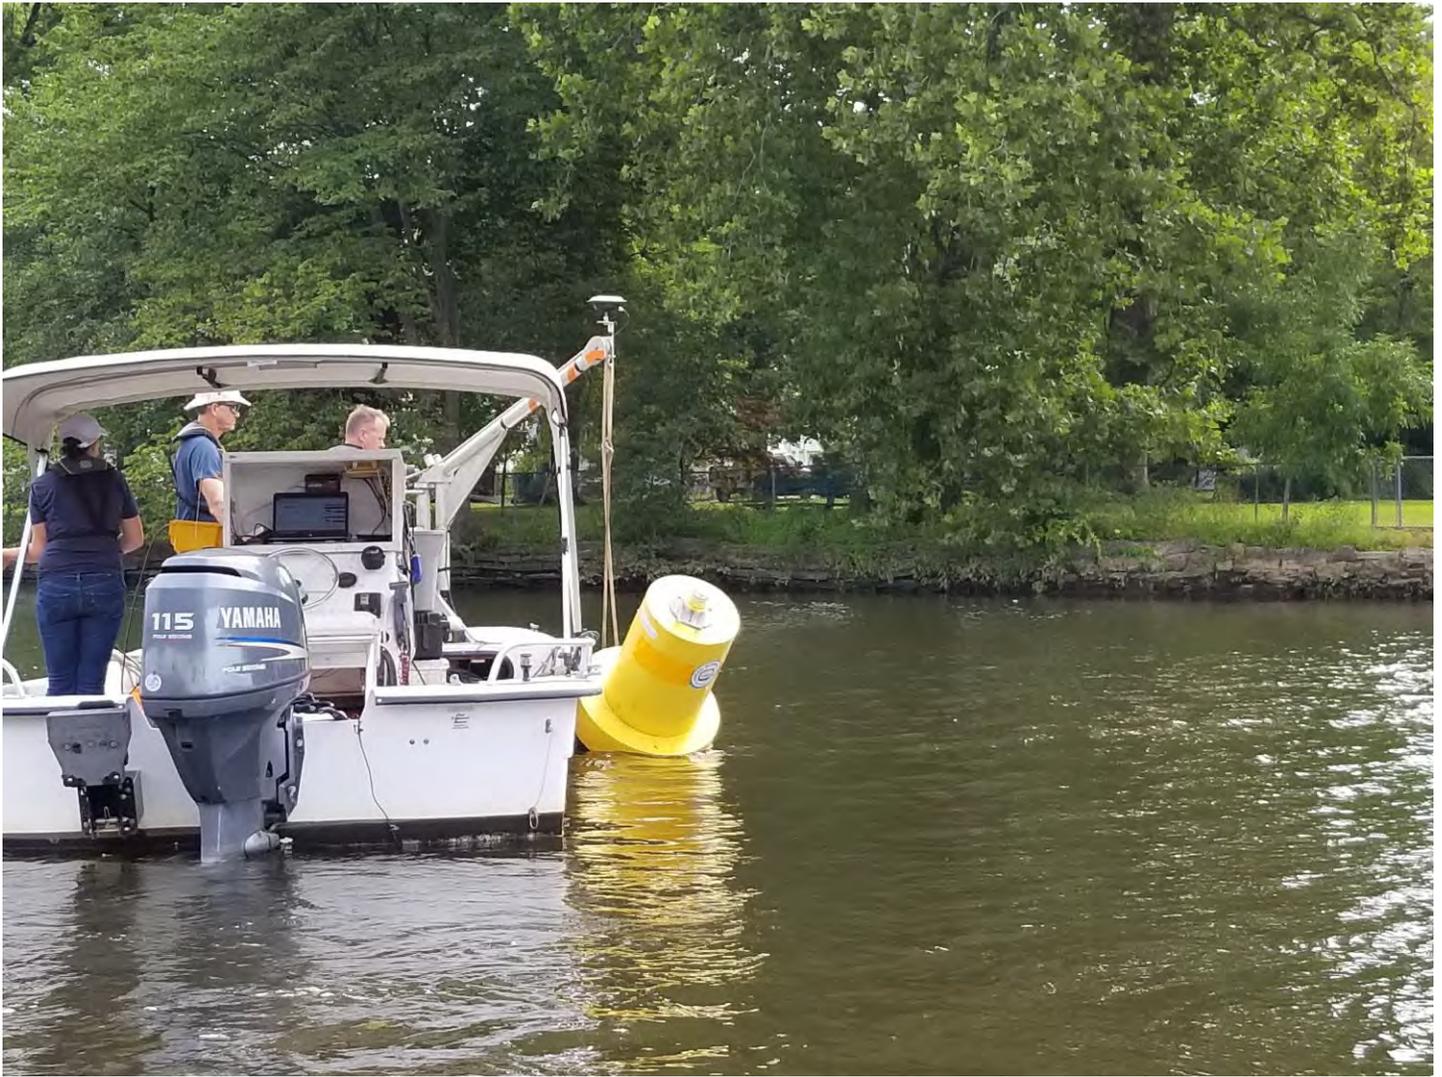
Photograph 2: OSI gathering YSI from the bottom of the surface buoy at RM 12.0

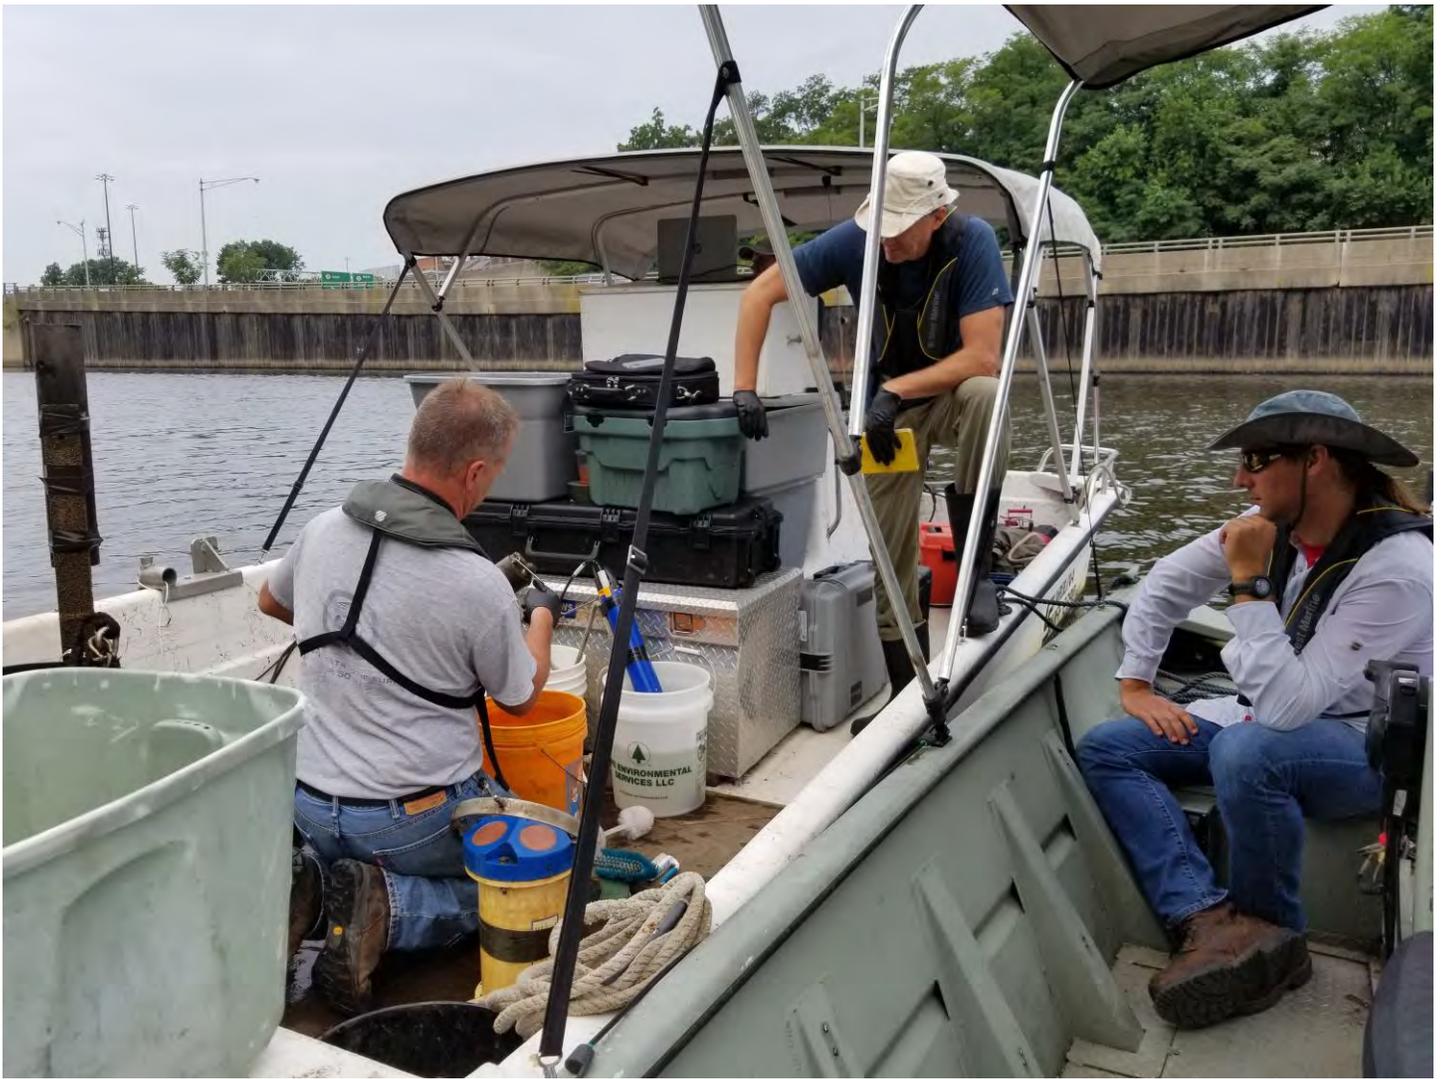
Photograph 3: OSI cleaning off YSI probes and checking calibration compared to boat YSI at RM 12.0

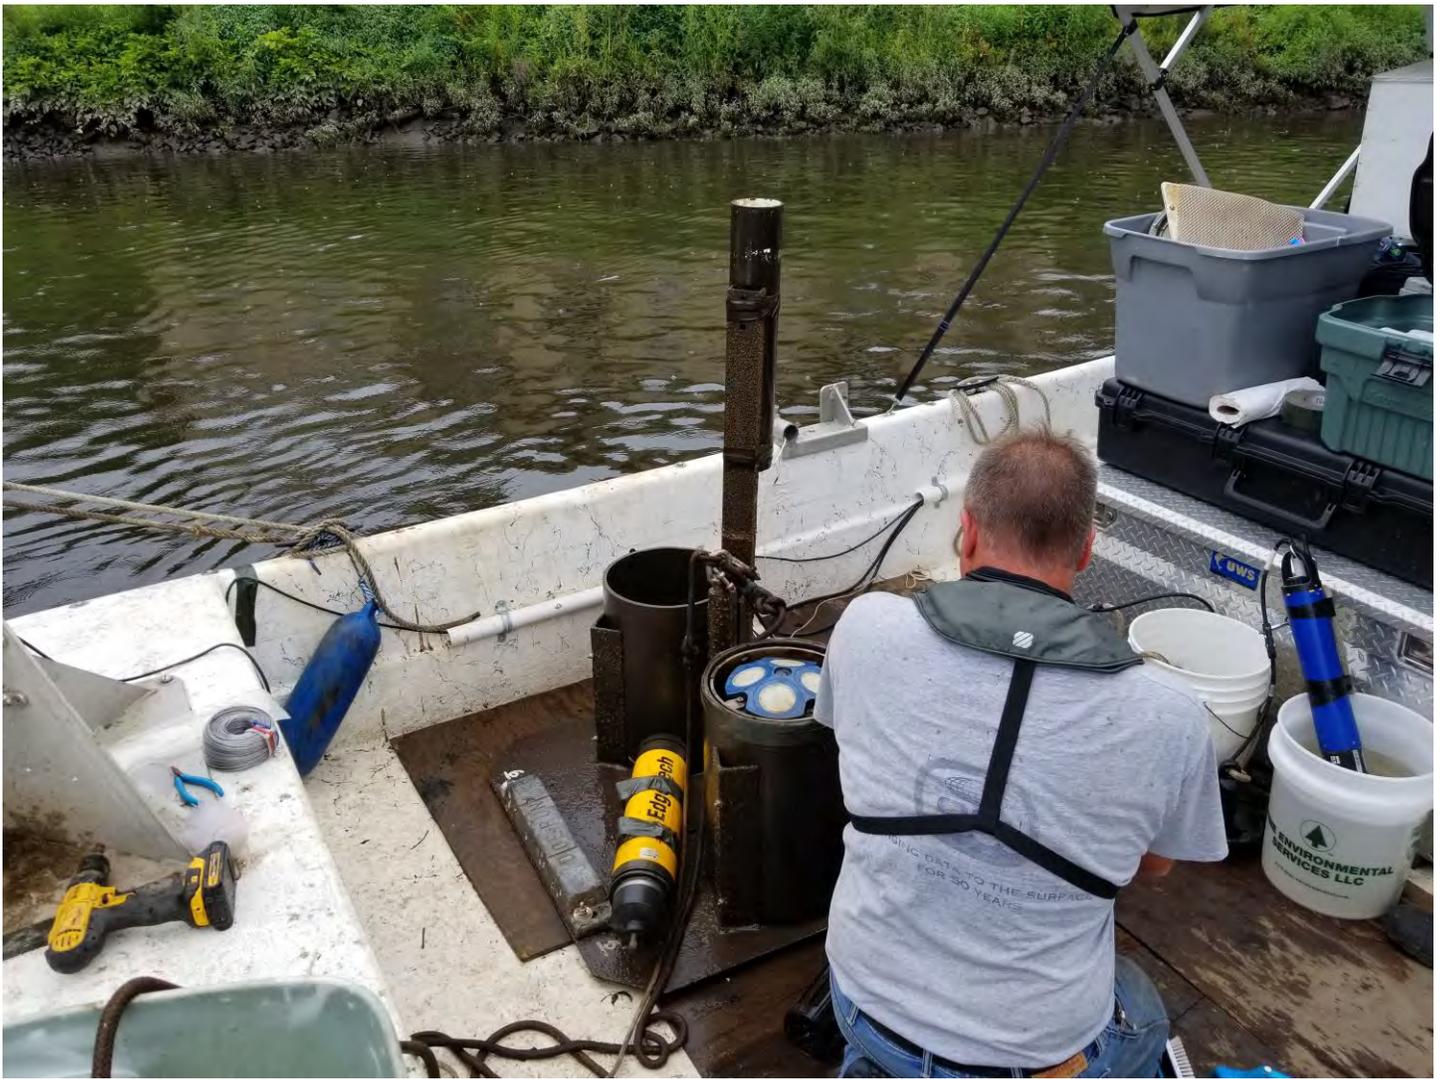
Photograph 4: OSI cleaning off ADCP on mooring and checking sensors to ensure working condition at RM 10.2

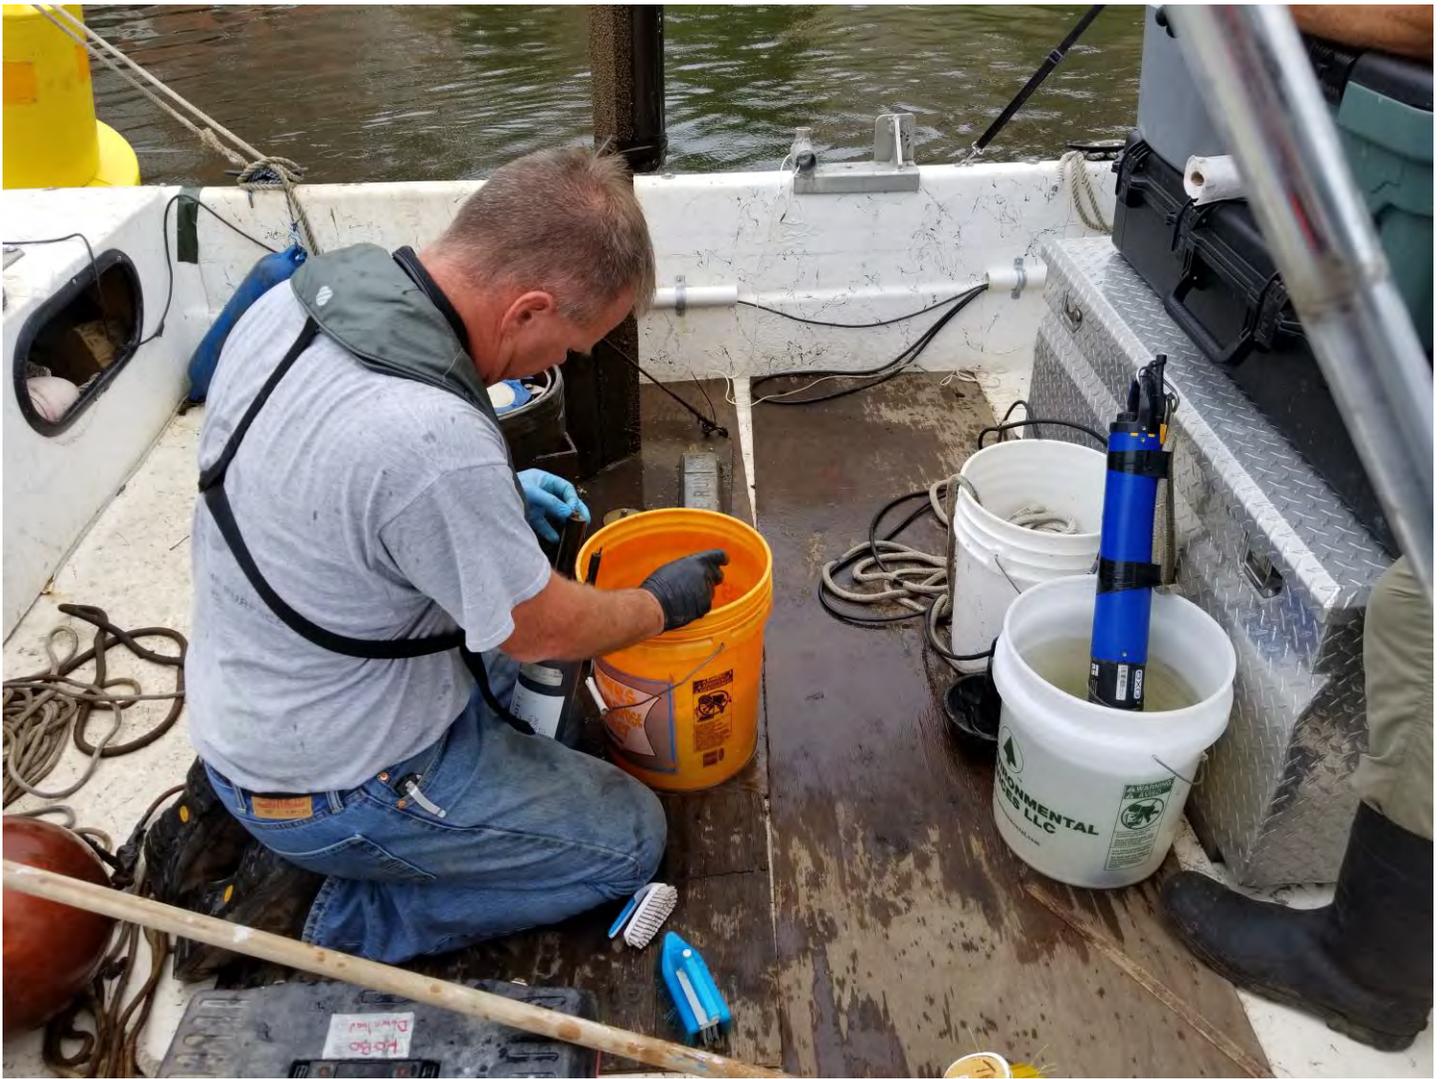
noted that the wiper was no longer functional. The probes on the RM 10.2 YSI were replaced with new probes, and then the YSI was calibrated to ensure accurate readings. The comparison with the boat YSI was good. The ADCP was removed, cleaned, had its data downloaded, and its four sensors were confirmed to be functional. The ADCP and the YSI were both remounted onto the mooring and the locator buoy was reset. The mooring was then lowered back to its original position using the GPS located above the winch arm. A vertical YSI profile was collected at RM 10.2 before departing from the location.

Photograph 5: OSI cleaning off individual sensors on YSI with small brushes at RM 10.2

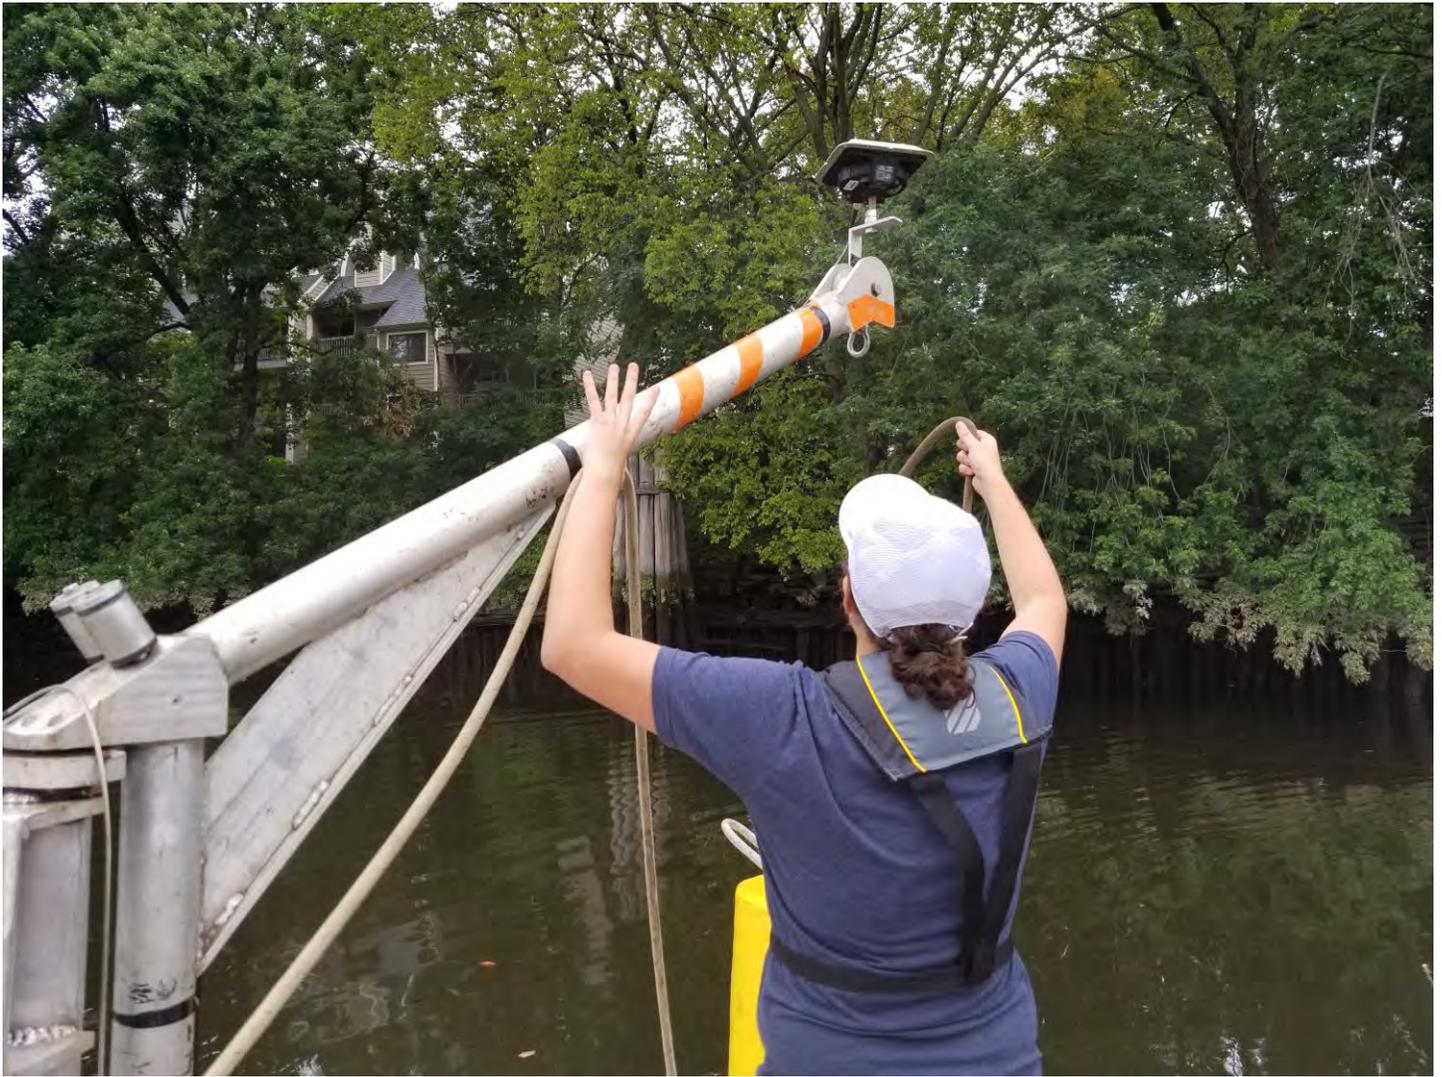
Photograph 6: OSI using the winch to raise the buoy from the river to gather the YSI from RM 13.5

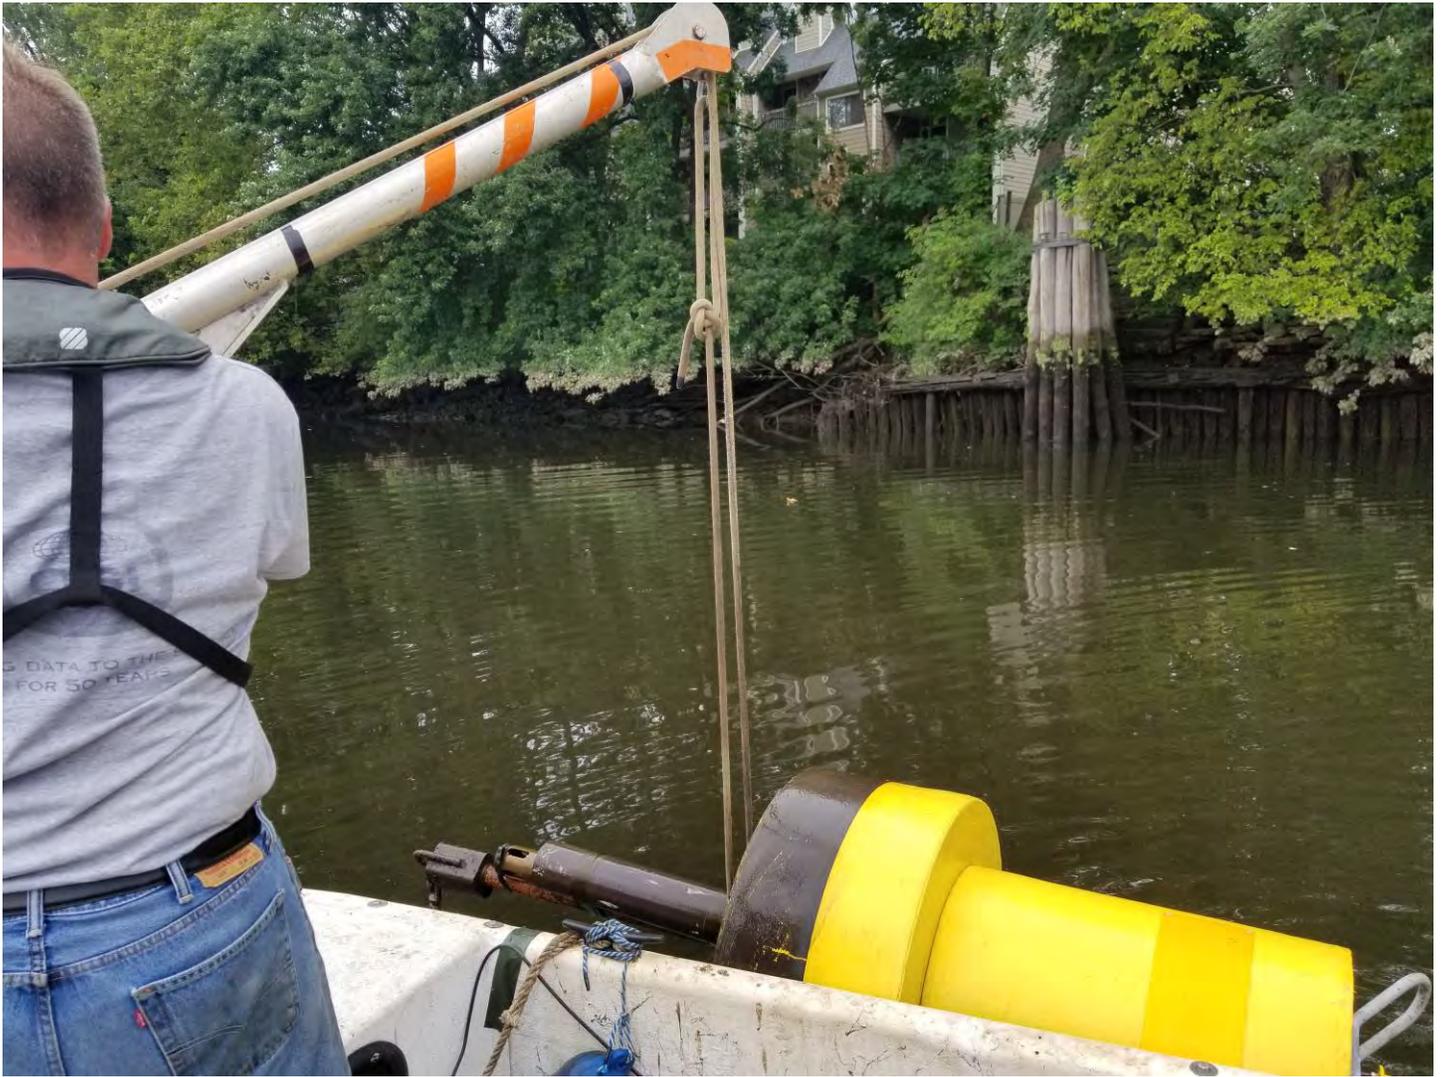
Photograph 7: OSI raising the YSI from the river using the winch at RM 13.5

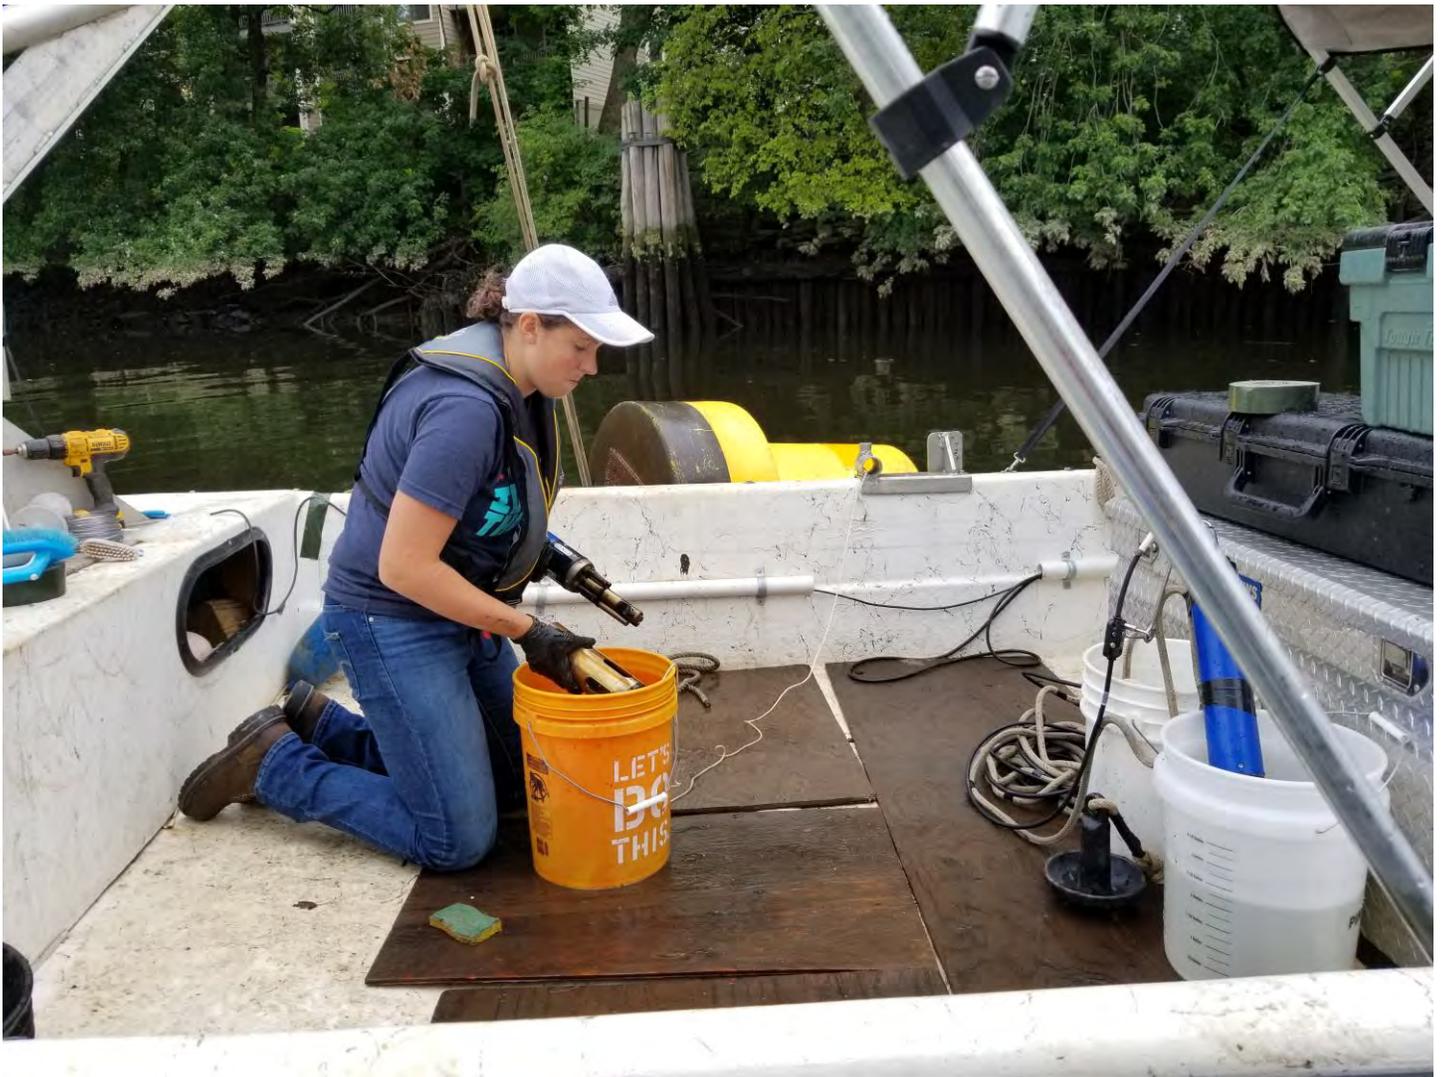
Photograph 8: OSI cleaning off the YSI and checking calibration at RM 13.5

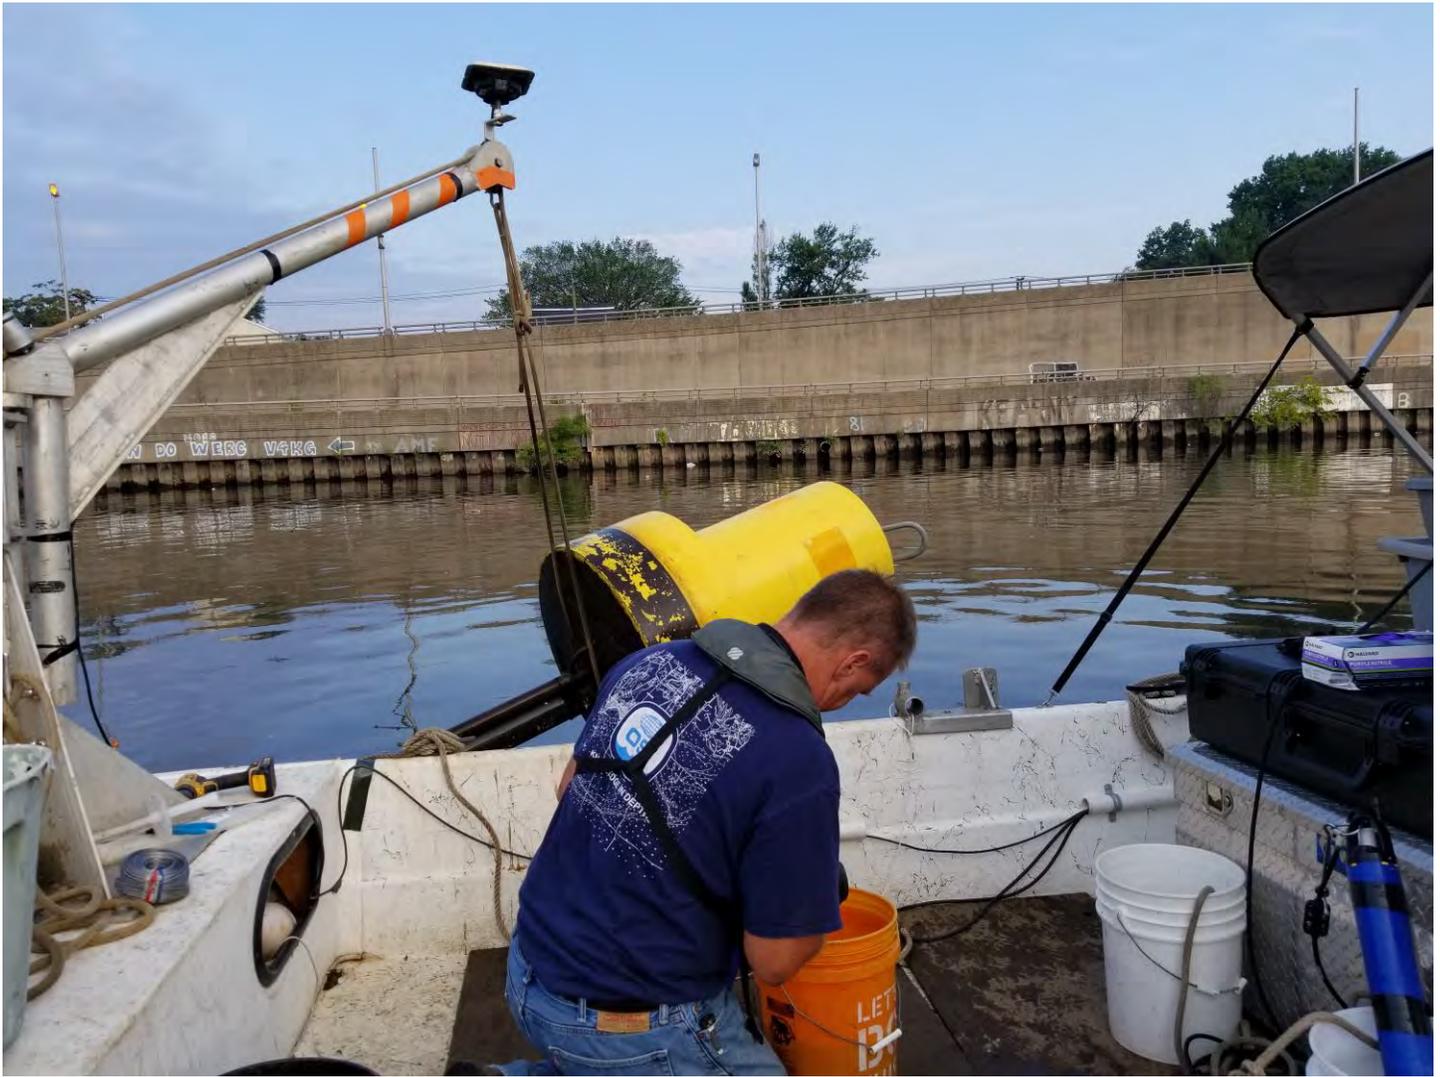
Photograph 9: Raised buoy with the winch, and OSI cleaning off the YSI probes at RM 8.4

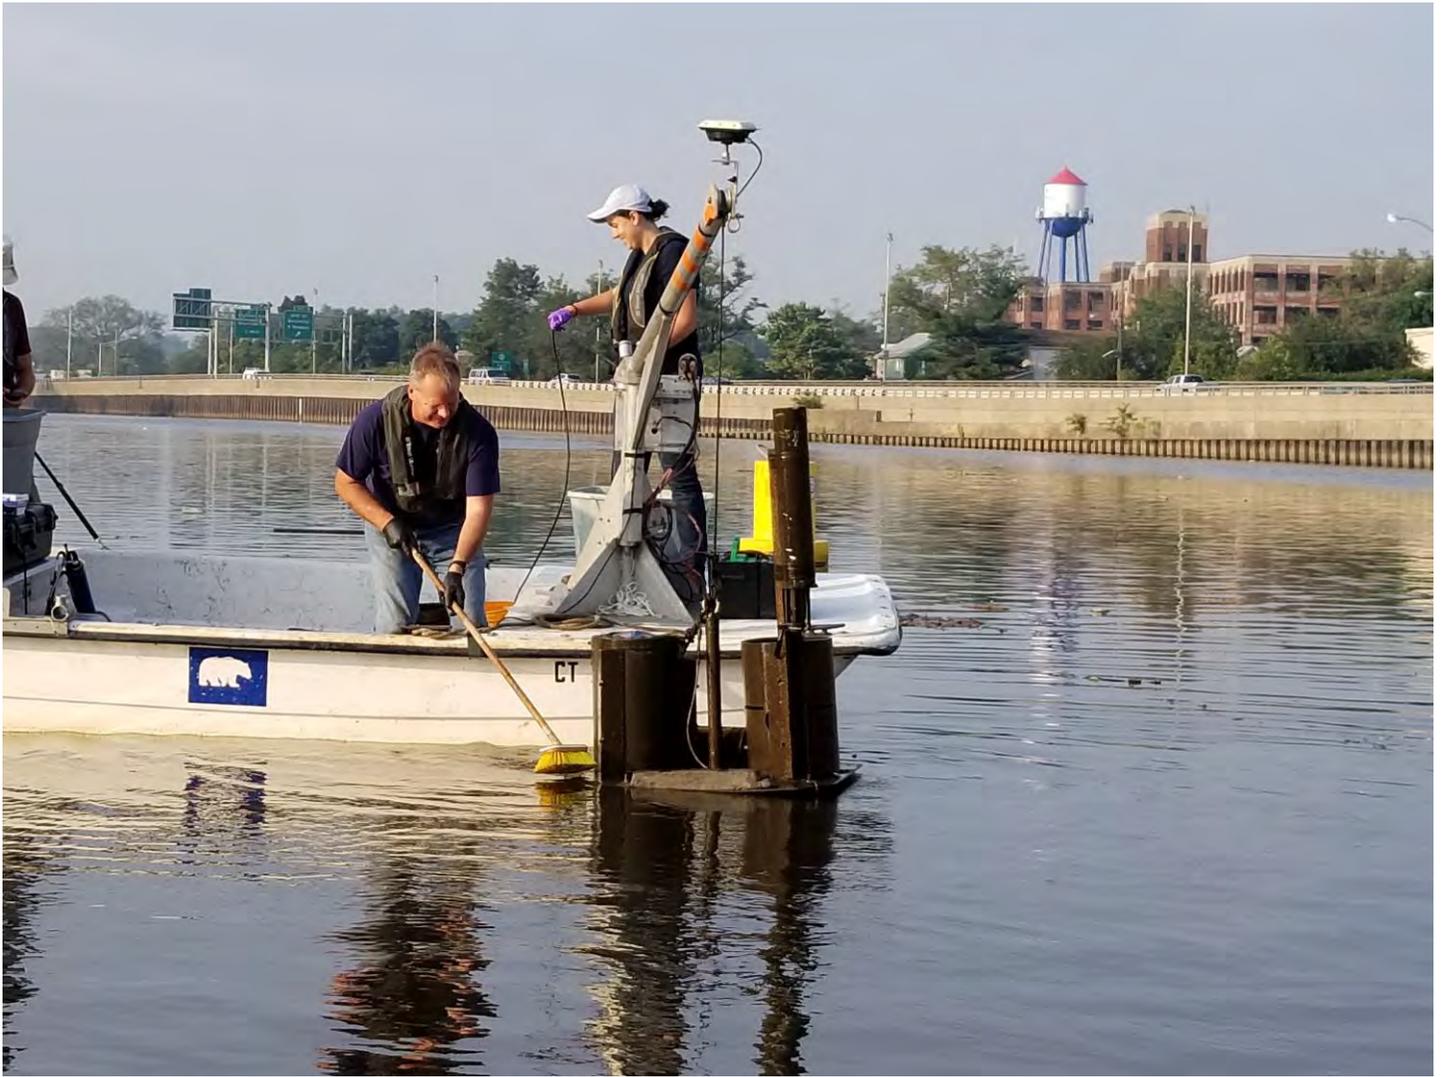
Photograph 10: OSI raising the mooring from the riverbed at RM 8.4 and cleaning off the casings
